1 • General view of the Lower City of Olbia.

Overview plan of Sector NGS.

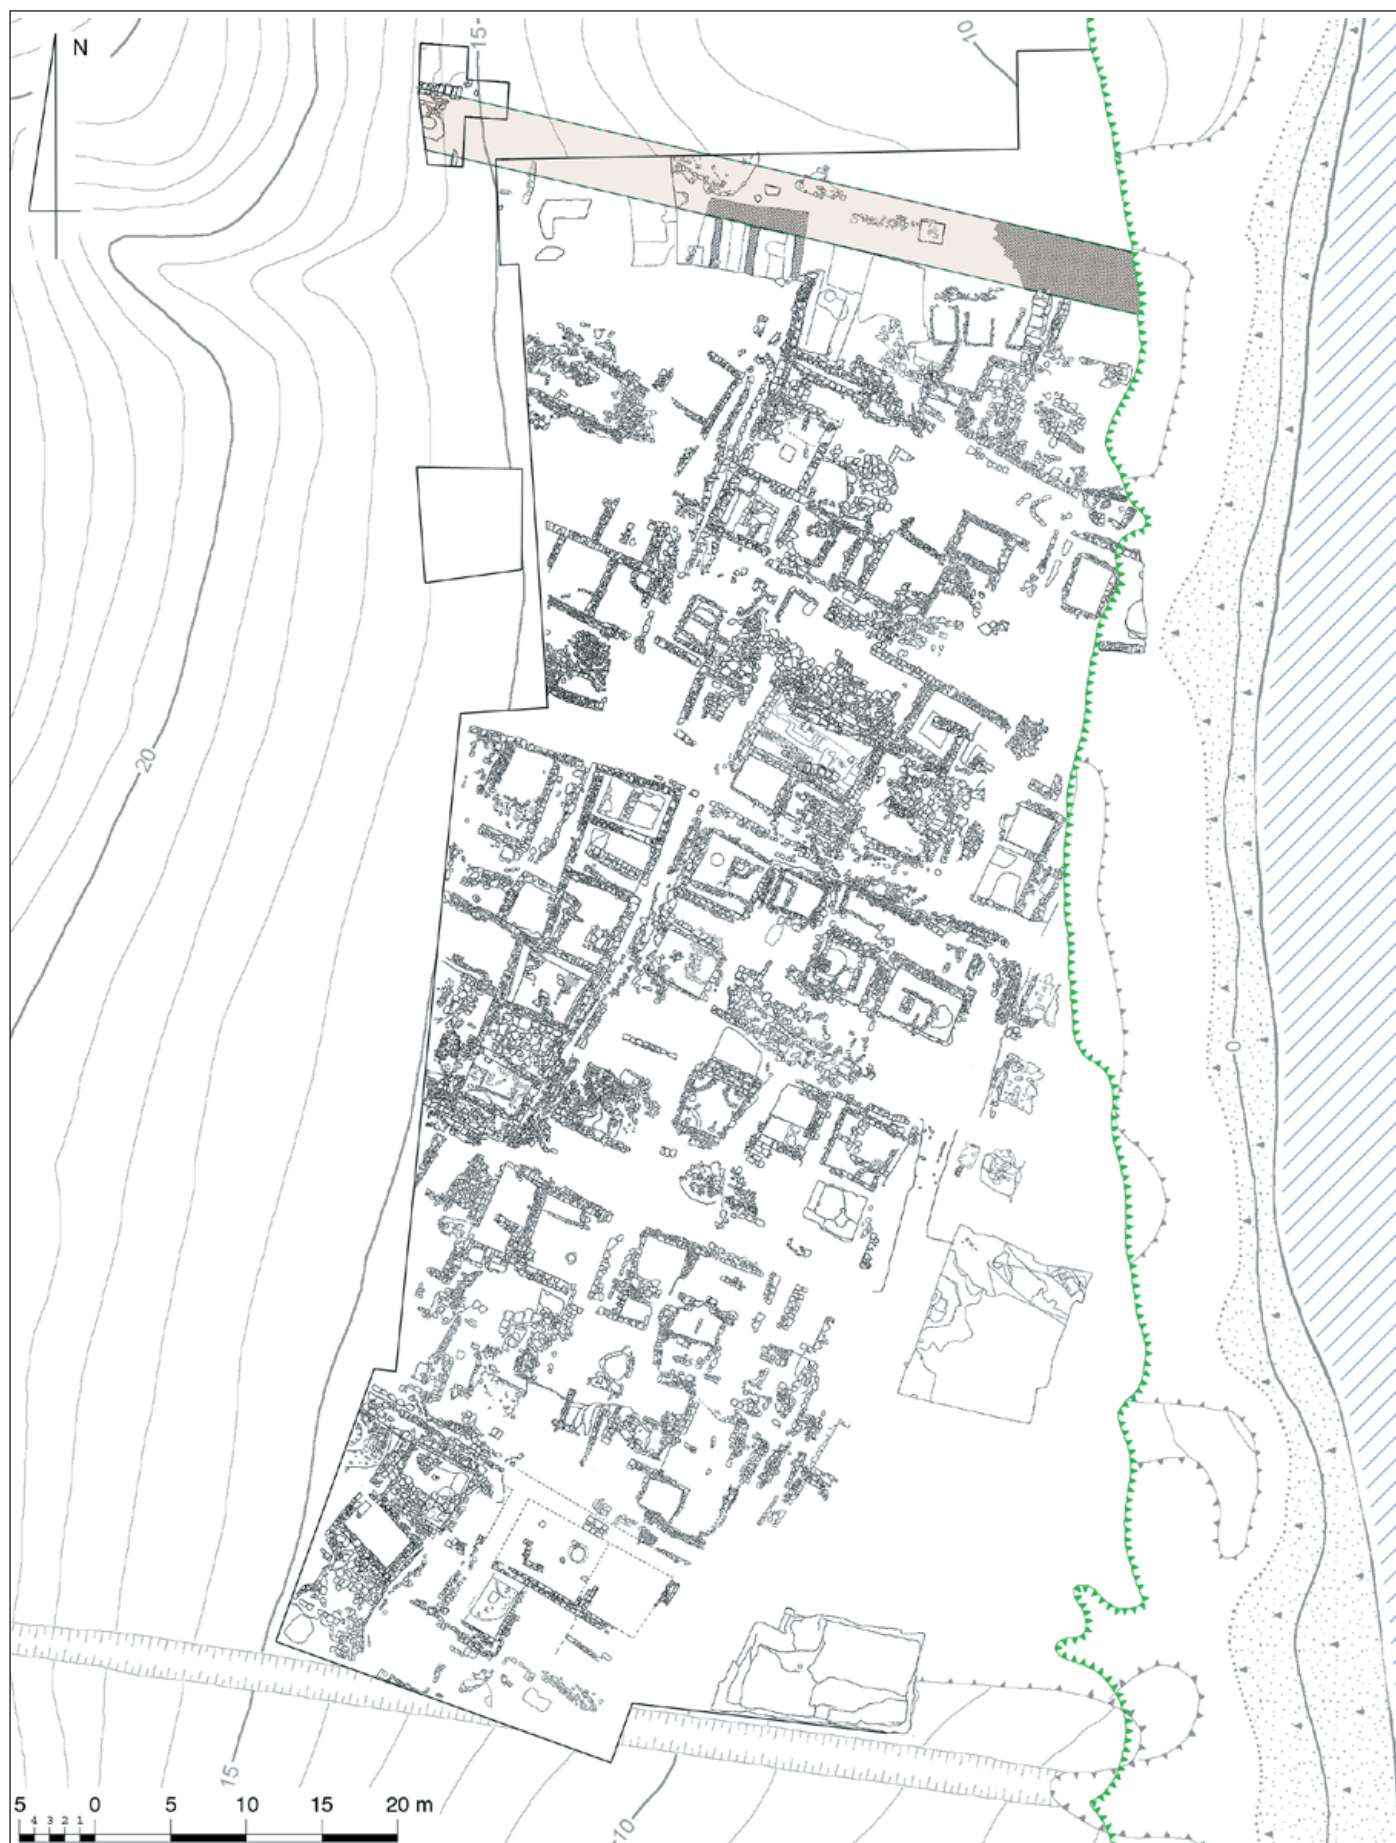
Overview plan of Sector NGS with topography of surrounding territory and infringements in cultural layers as a result of the erosion of the coastal cliff (green line) and trenches made during the Second World War (in pink). To the north, the area of the city wall (in yellow).

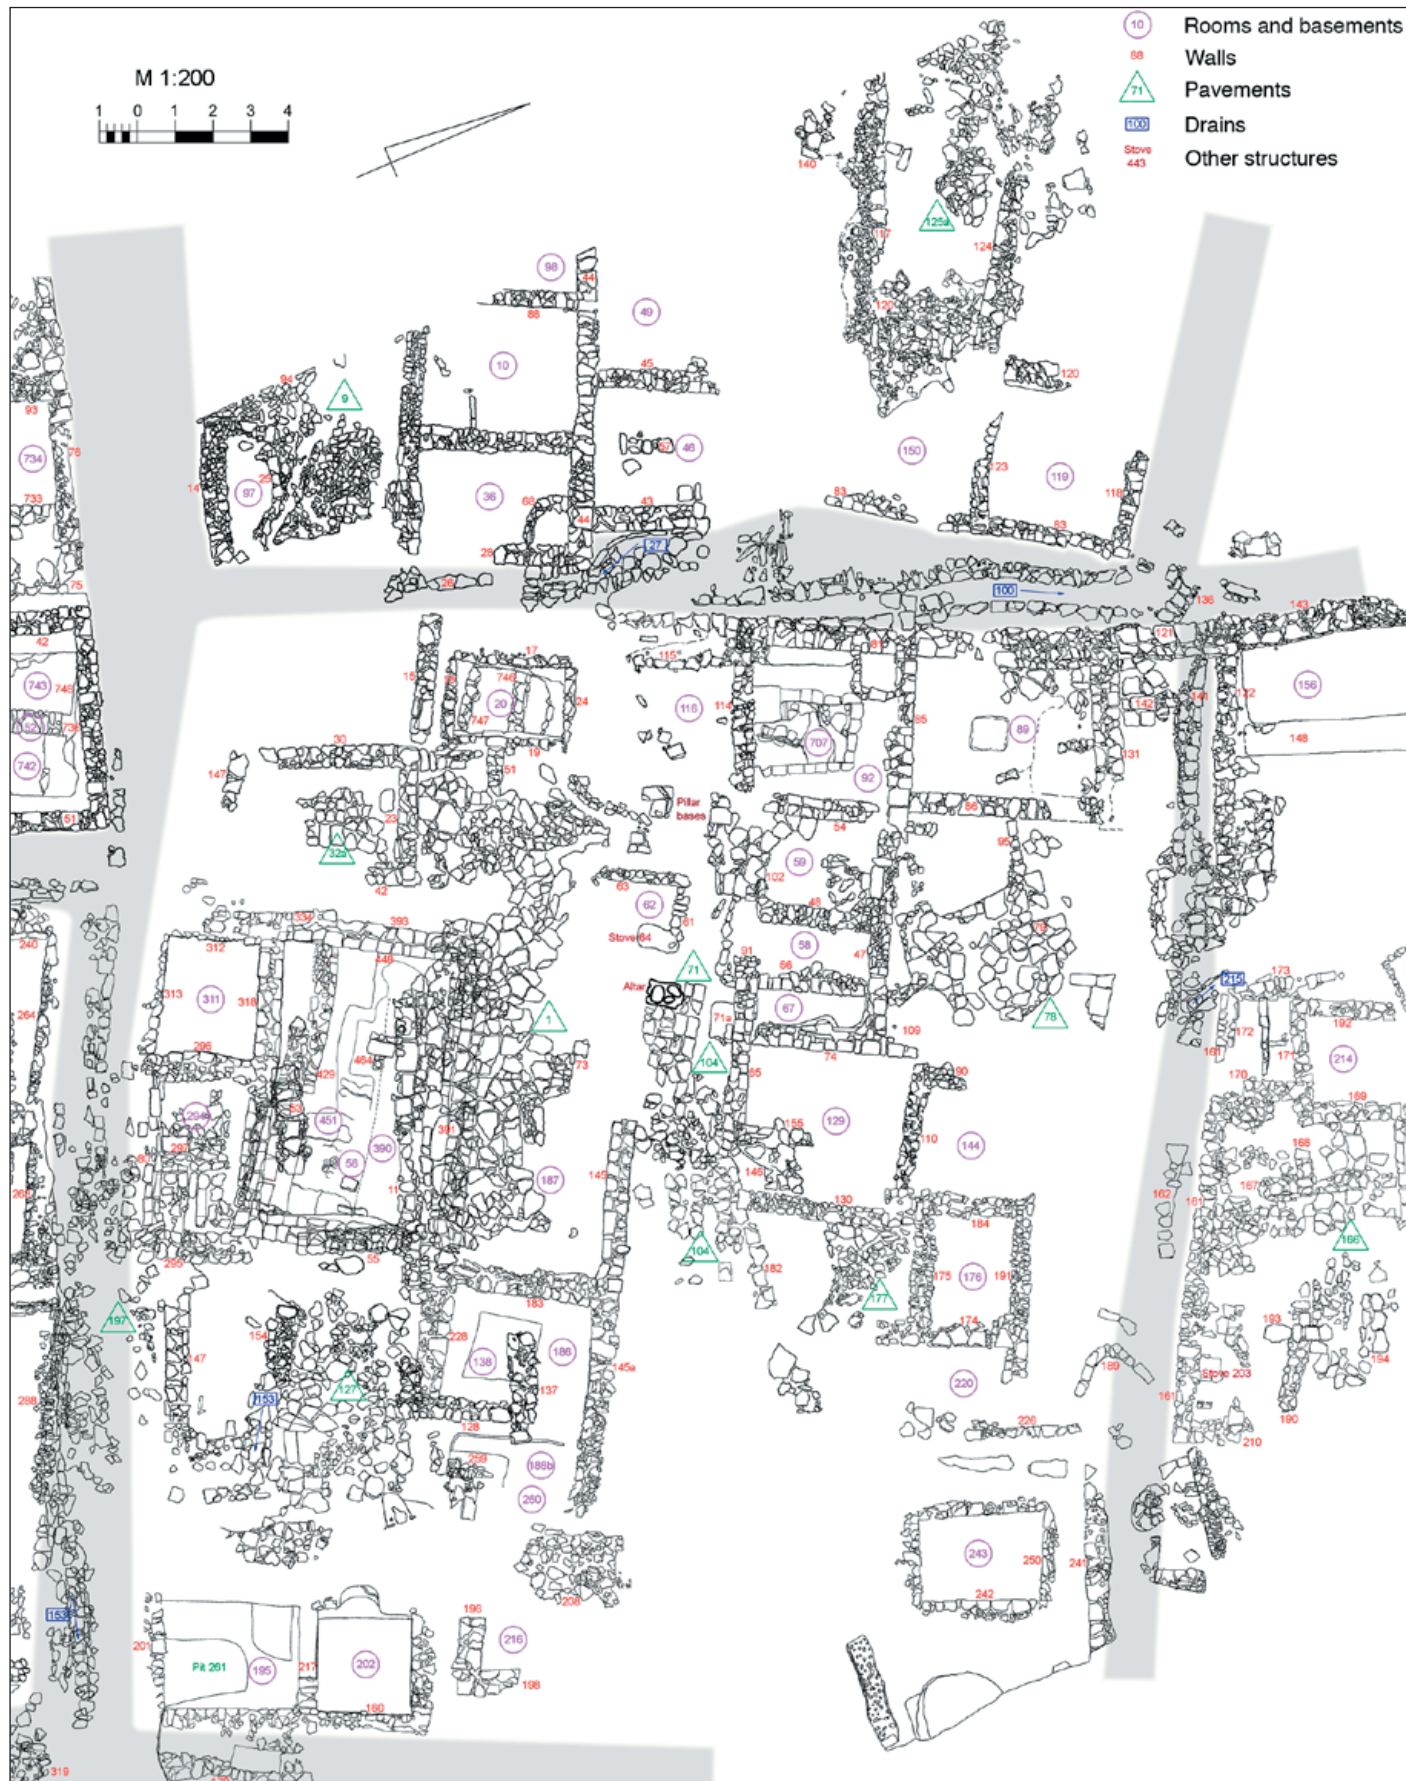
Overview plan of Northern and Northwestern Houseblocks.

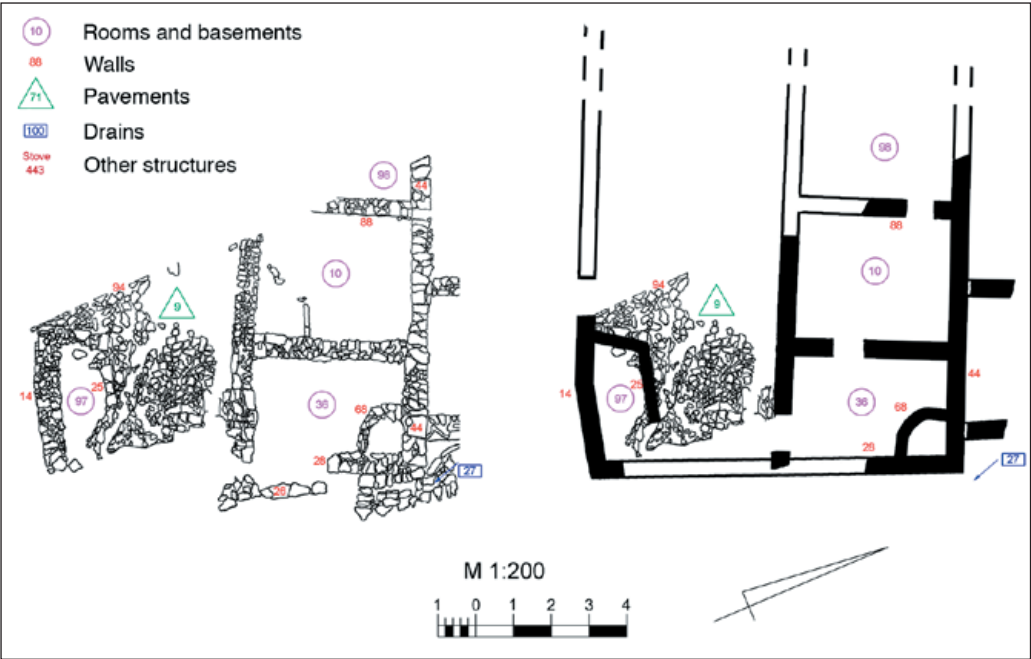
2-3 • House I-1. Plan and reconstruction.

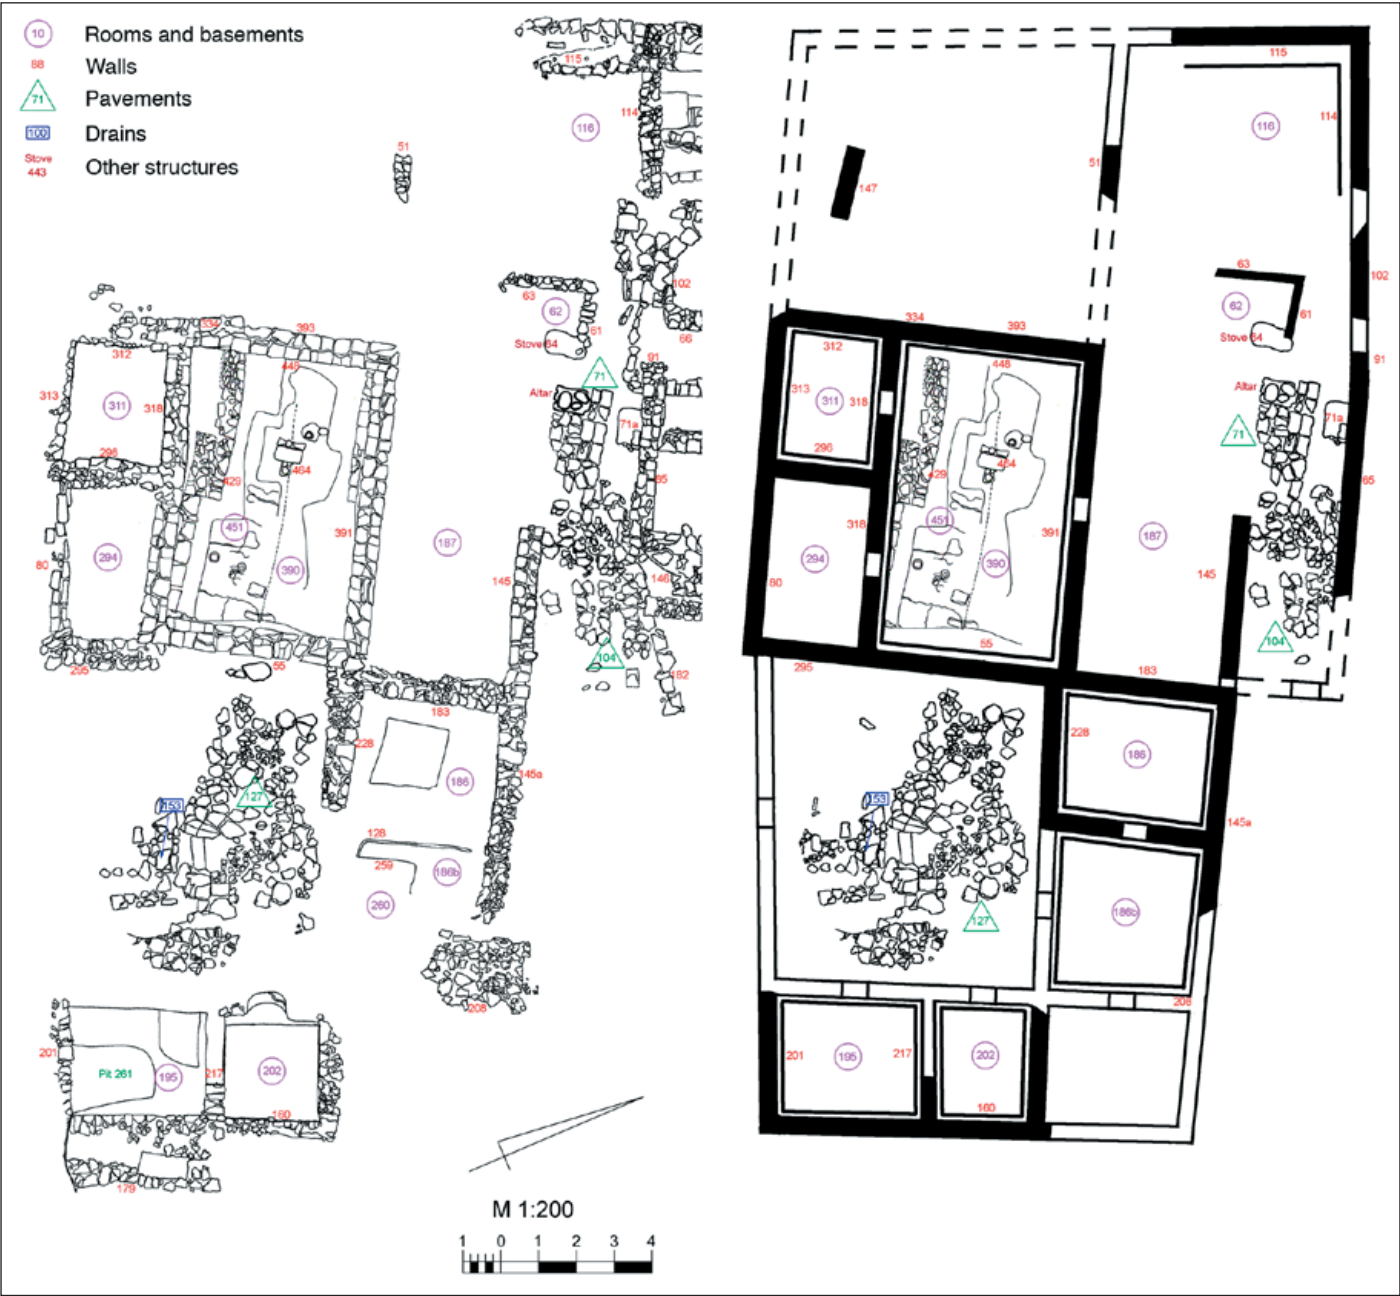
1-2 • Houses II-5 and II-6. Plan and reconstruction.

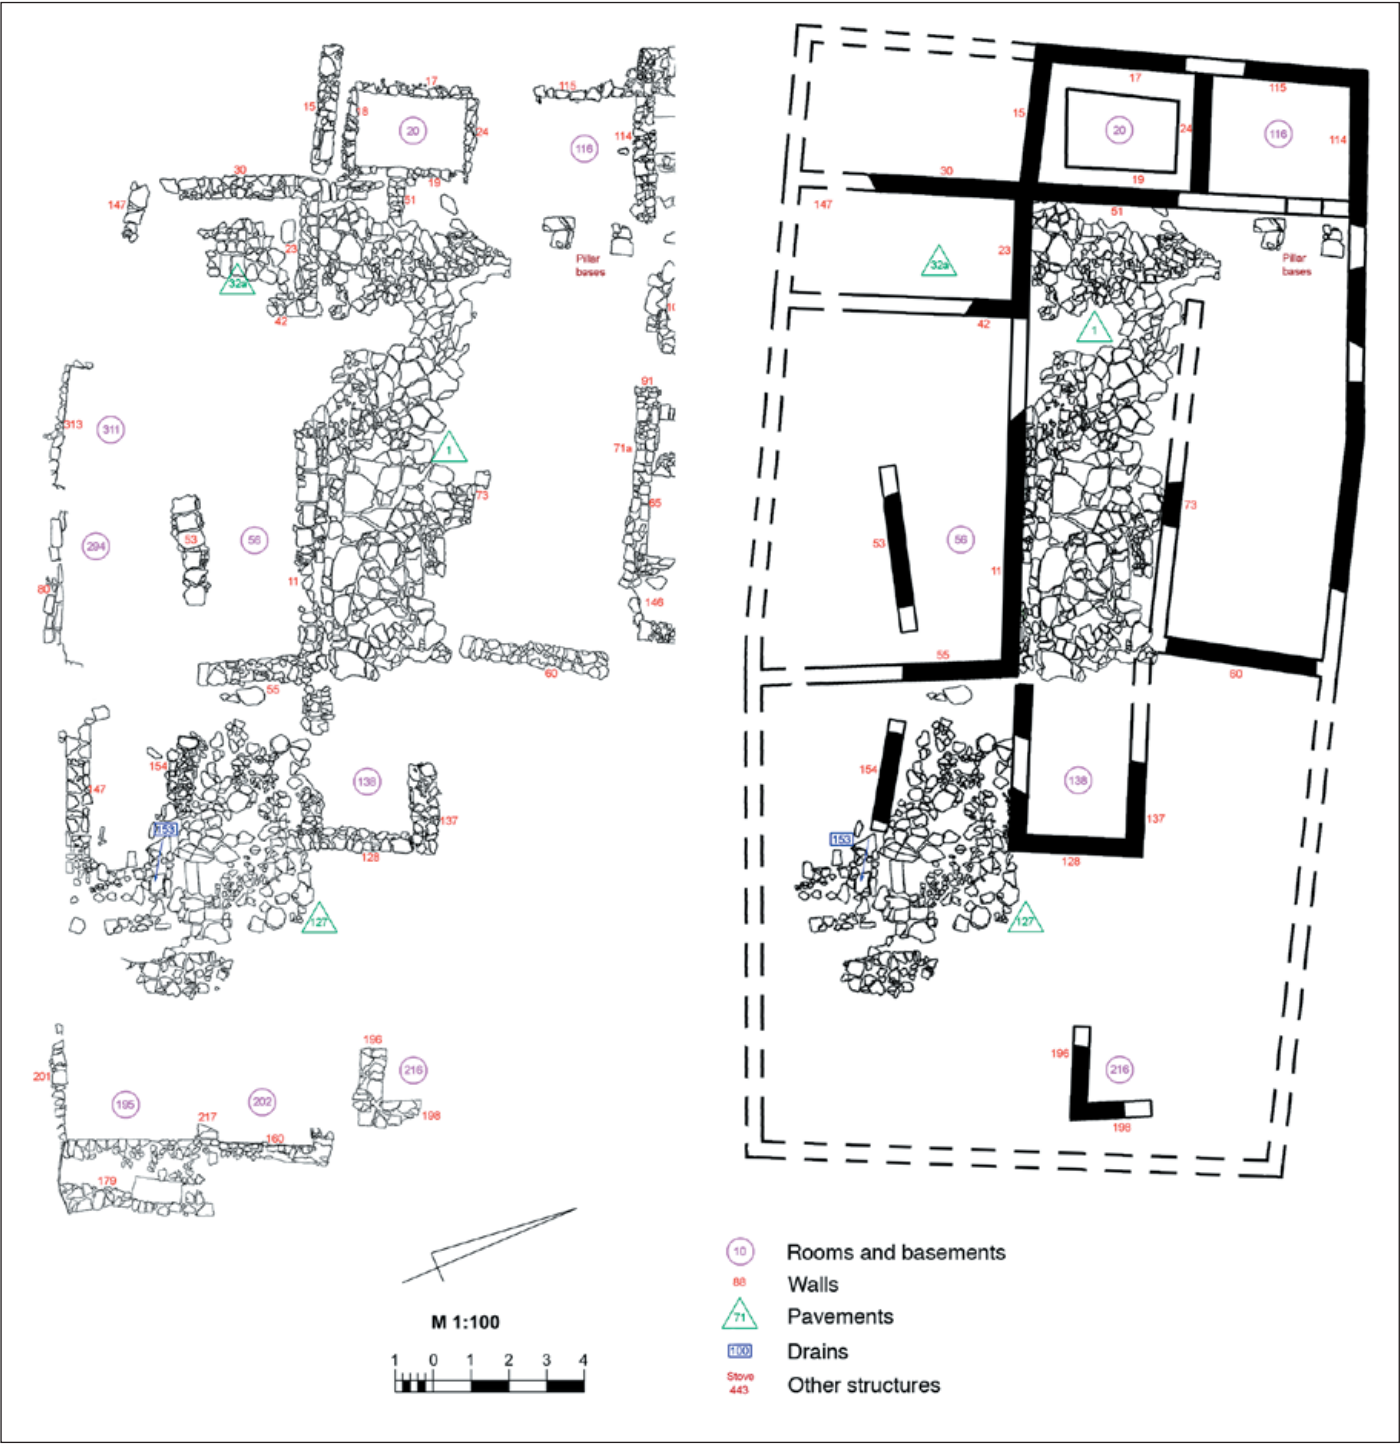
1-2 • House II-7. Plan and reconstruction.

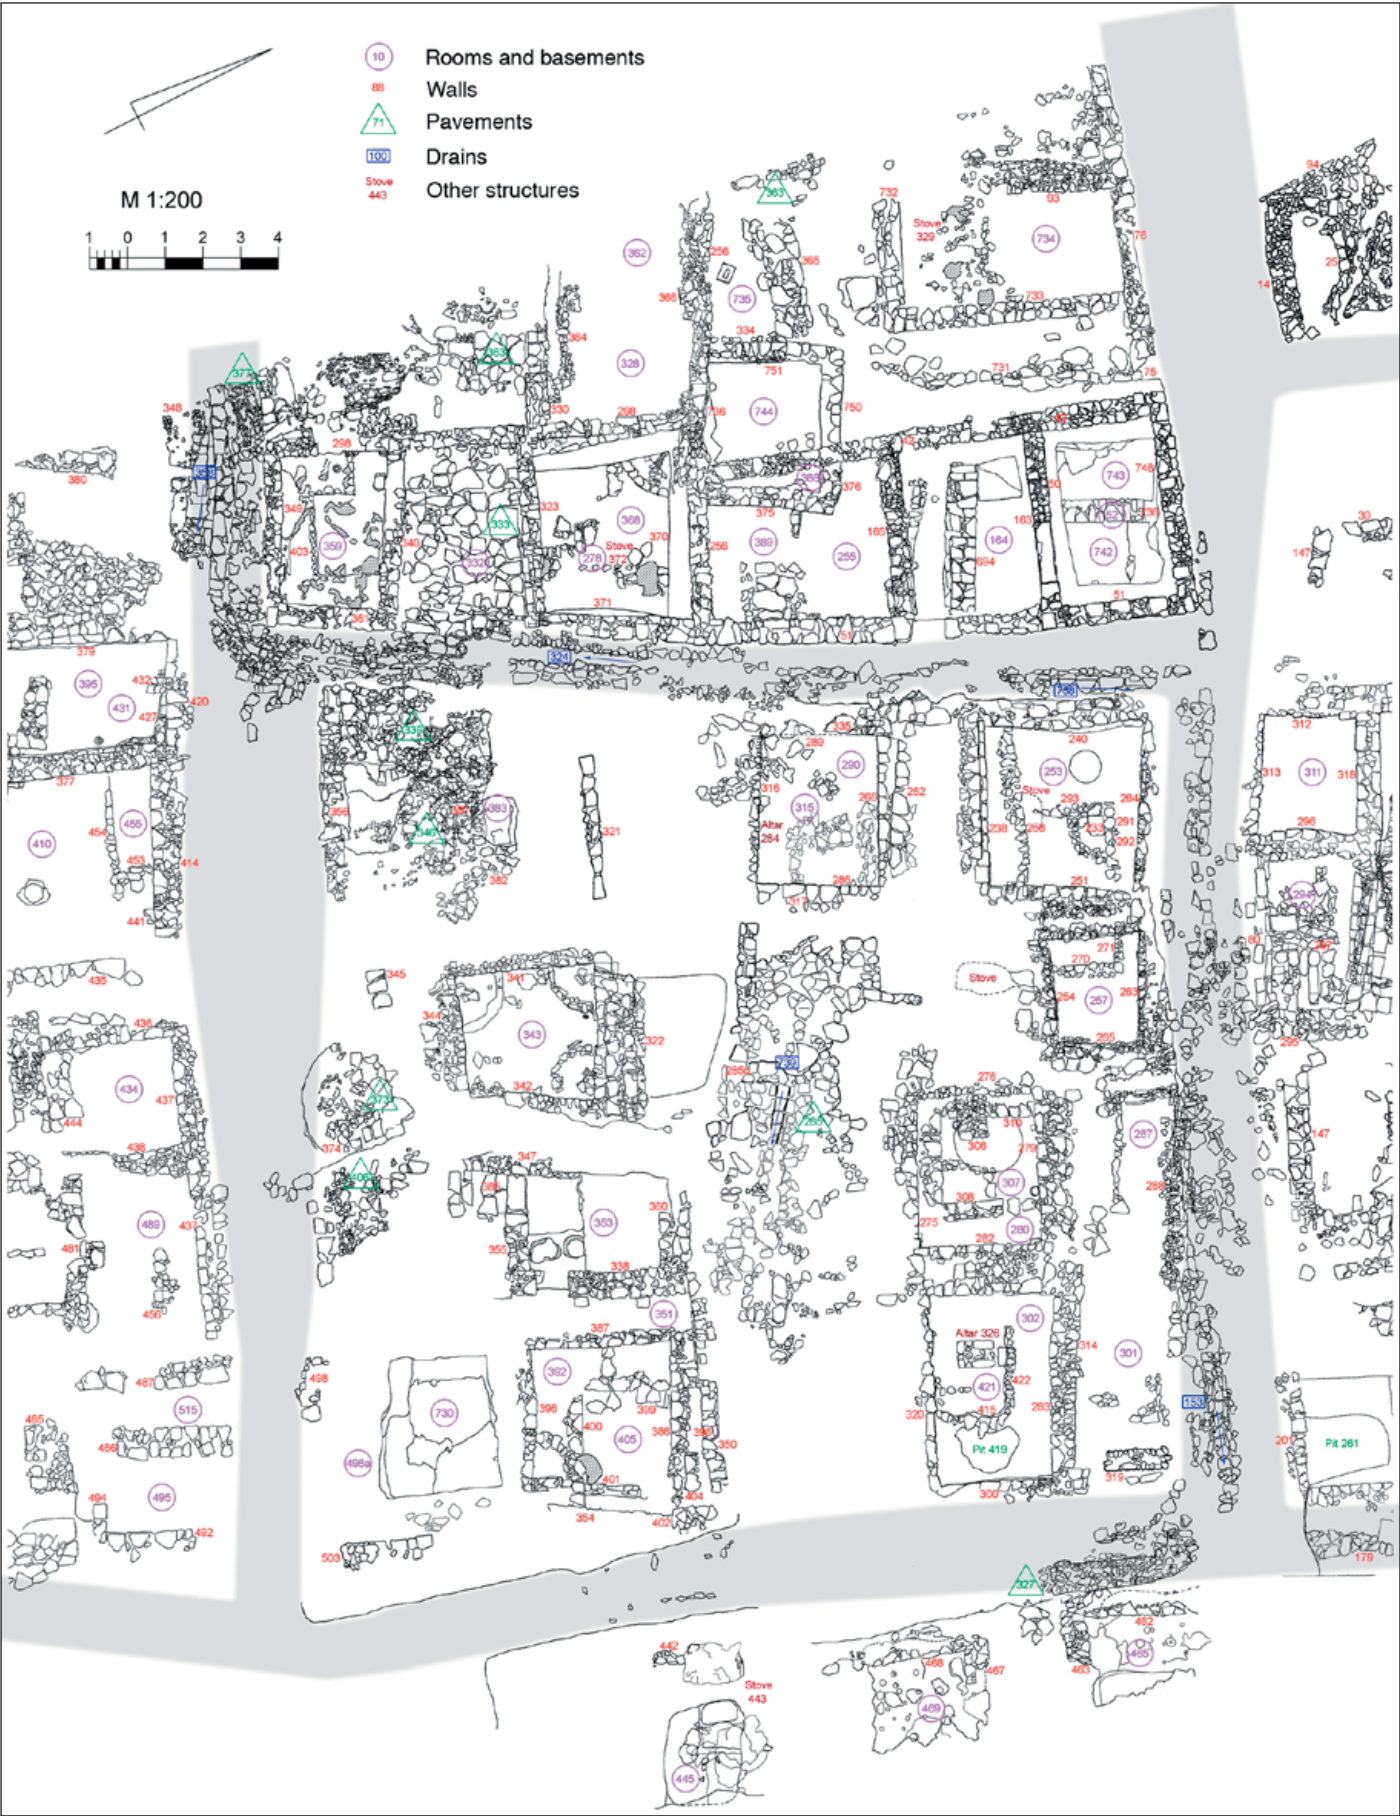
The Western and Central Houseblocks. Plan.

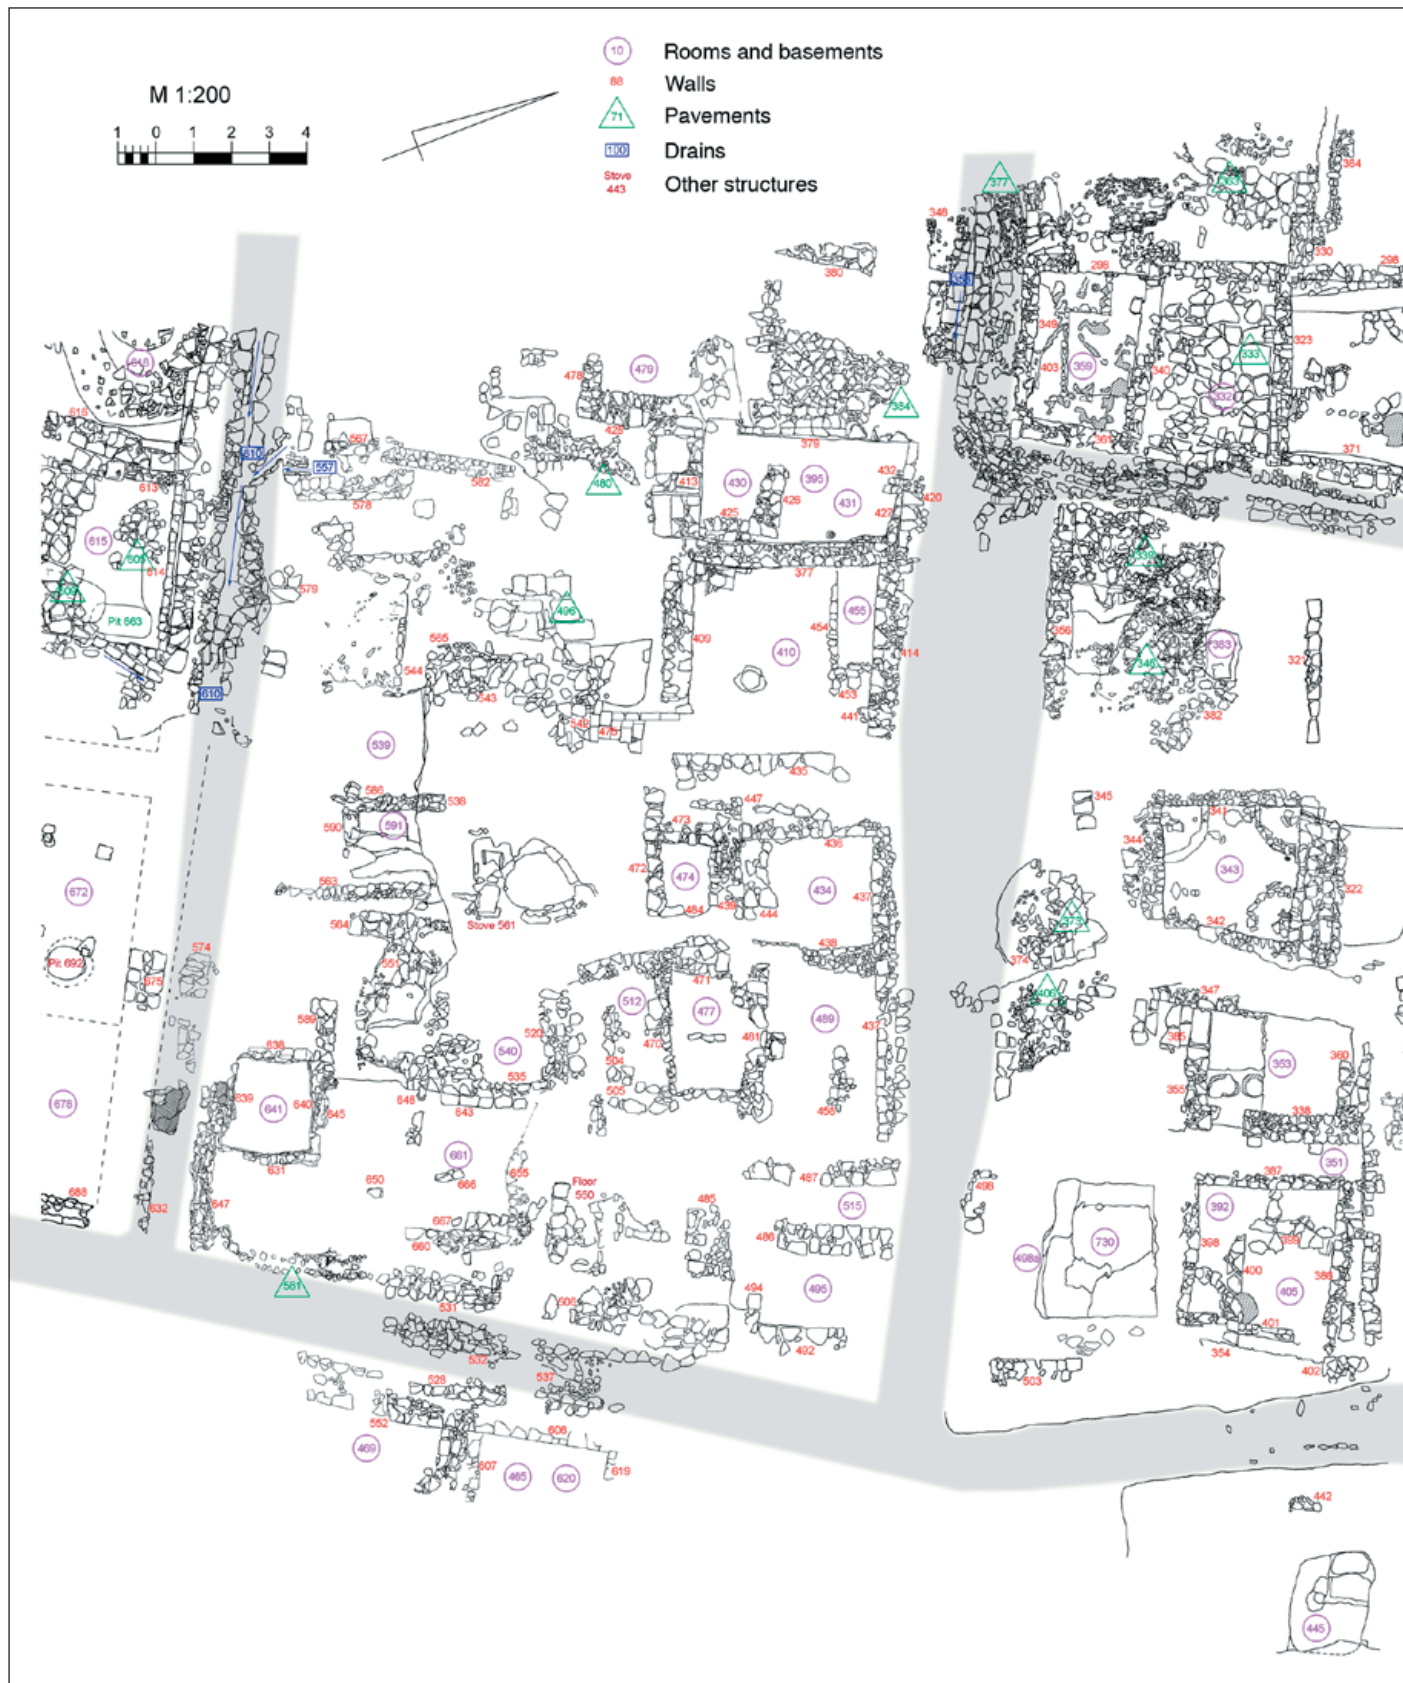
Southern Houseblock. Plan.

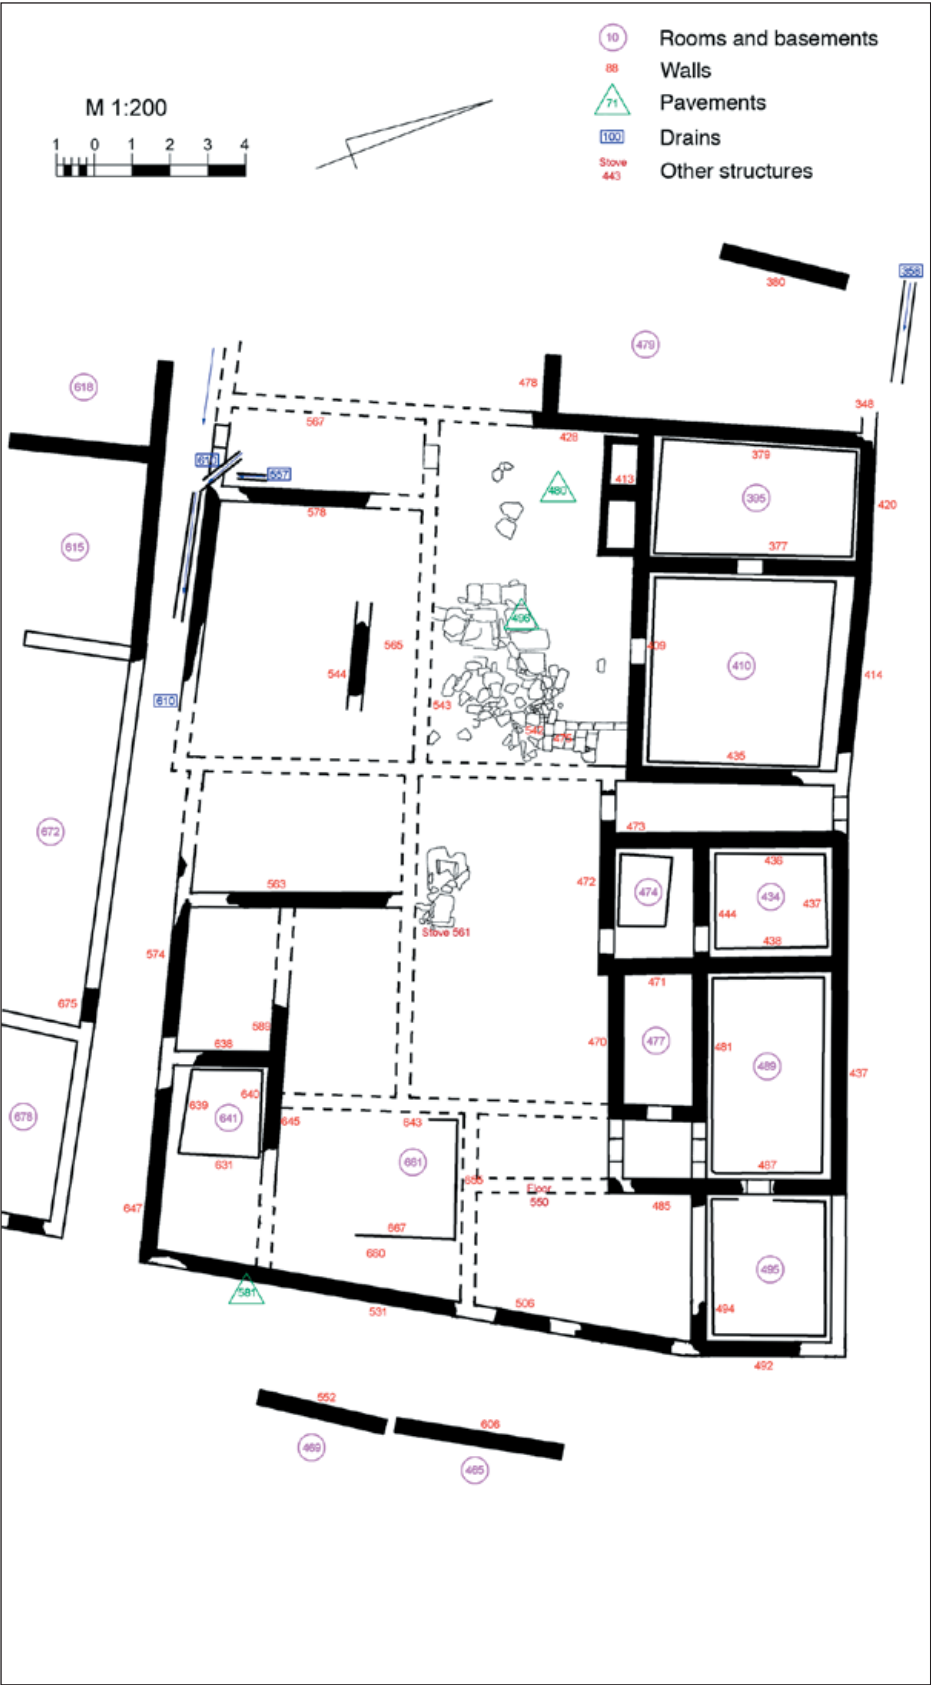
Houses of the Southern Houseblock. Reconstruction.

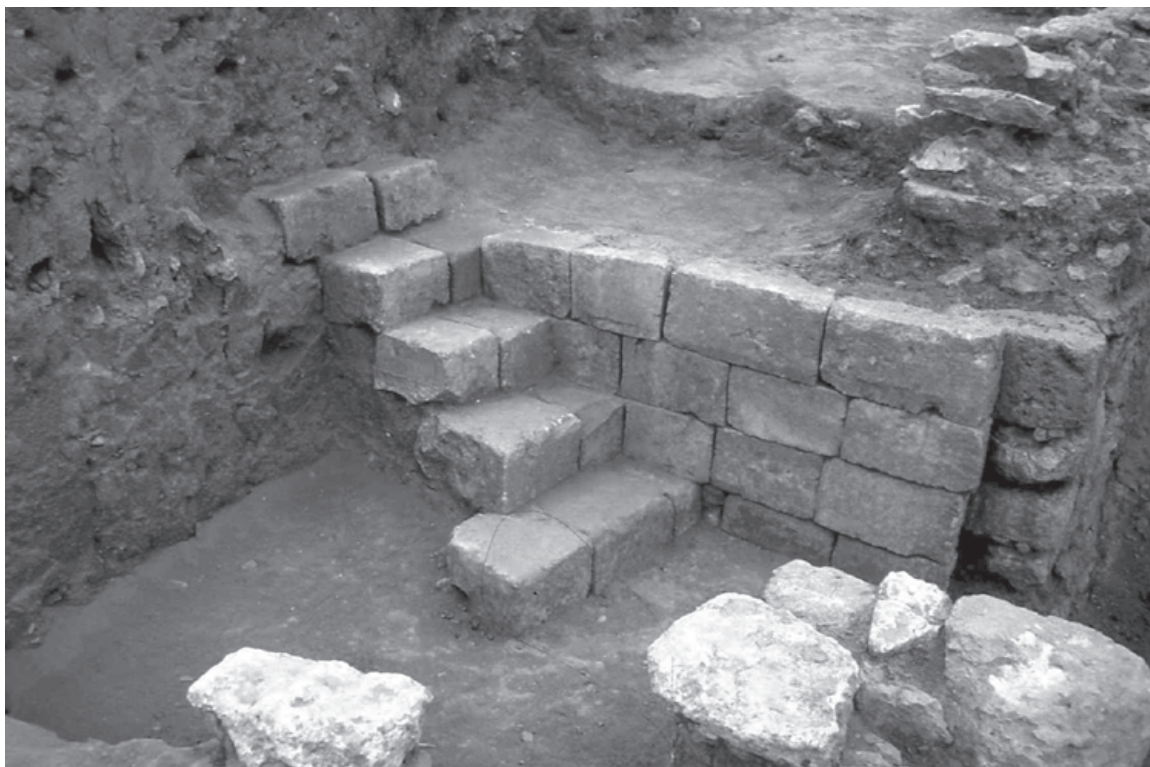
1 • House VI-2, staircase in Basement 410. View from northeast.

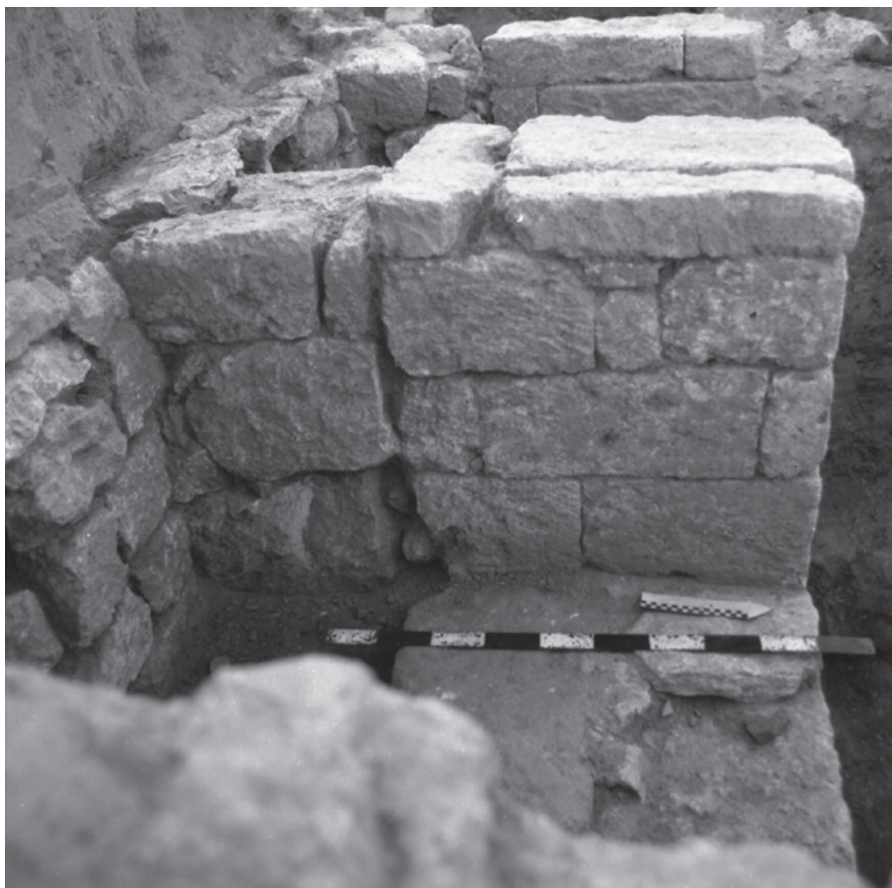
2 • House VI-2, Basement 395. Window aperture. View from the east.

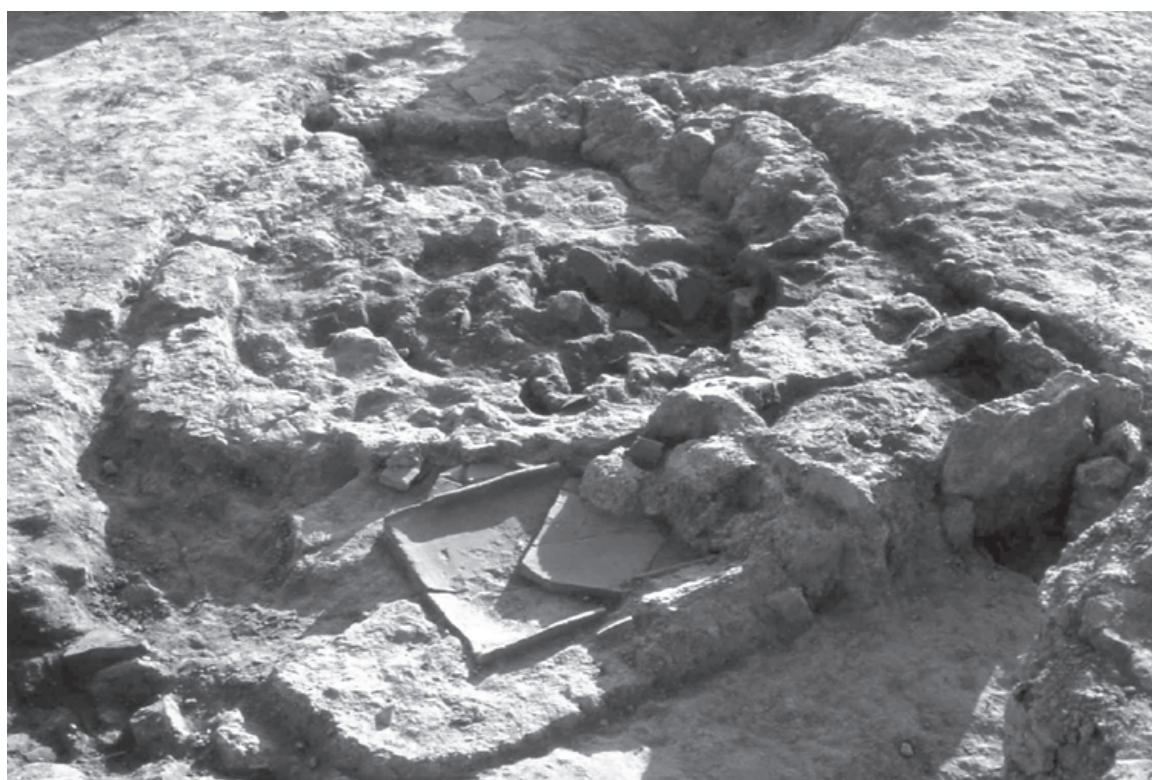
2 • House VI-3, Stove 561. View from the southwest.

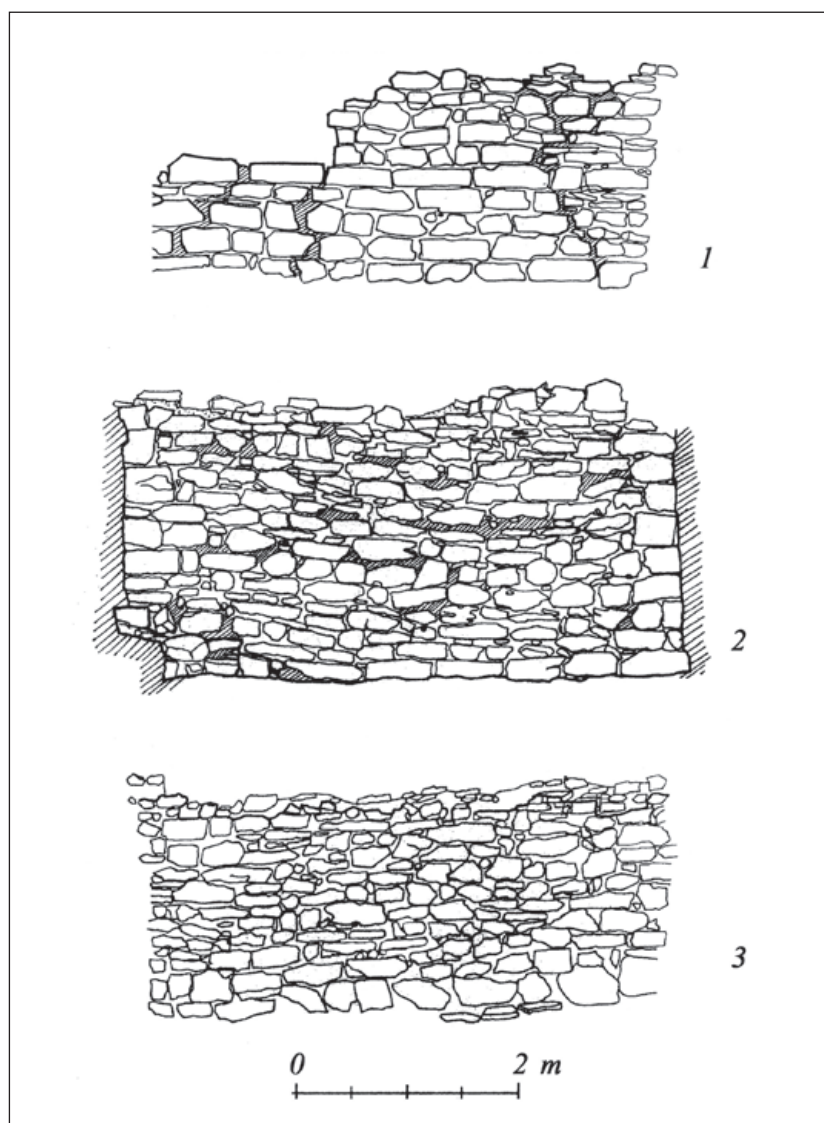
1 • Masonry techniques. 1: single-row wall of polygonal plates and blocks (Wall 320); 2: single-row, irregular (Wall 377); 3: irregular (Wall 370).

2 • Single-row of orthogonal plates and blocks. 1: Wall 318; 2: Wall 71; 3: Wall 72.

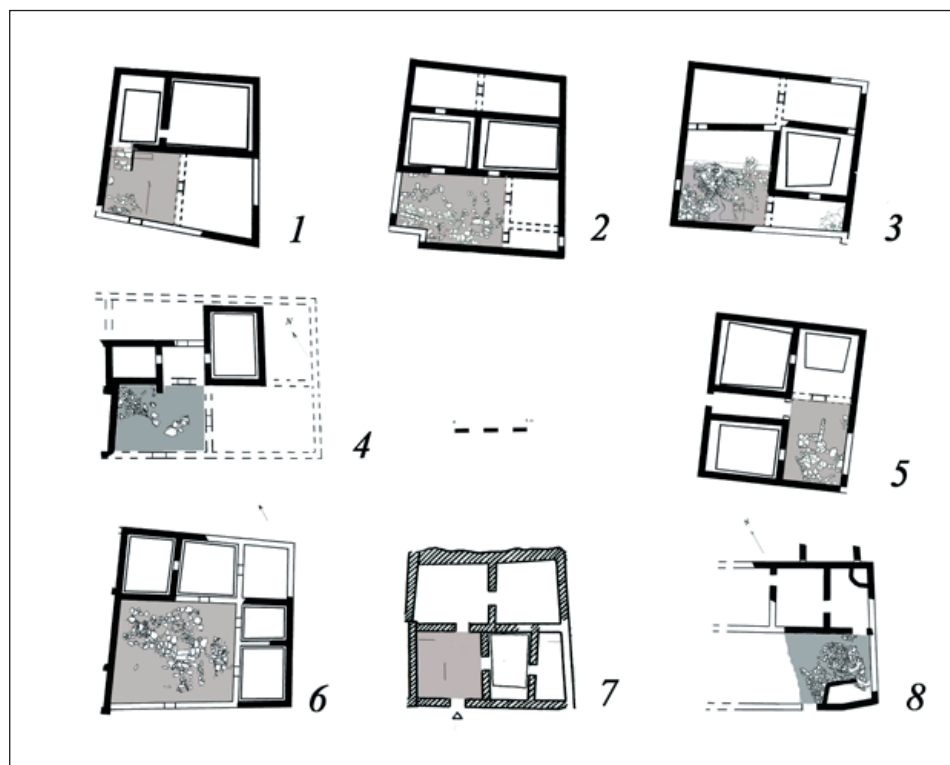
1 • Houses with Γ-shaped arrangement of rooms. Sector NGS, Central Houseblock: 1: House IV-4; 2: House IV-2; 3: House IV-3; 5: House IV-1. Sector NGS, Northwestern Houseblock: 8: House I-1. Sector NGS, Northern Houseblock: 4: House II-4; 6: House II-6. Sector I: 7: House I-2.

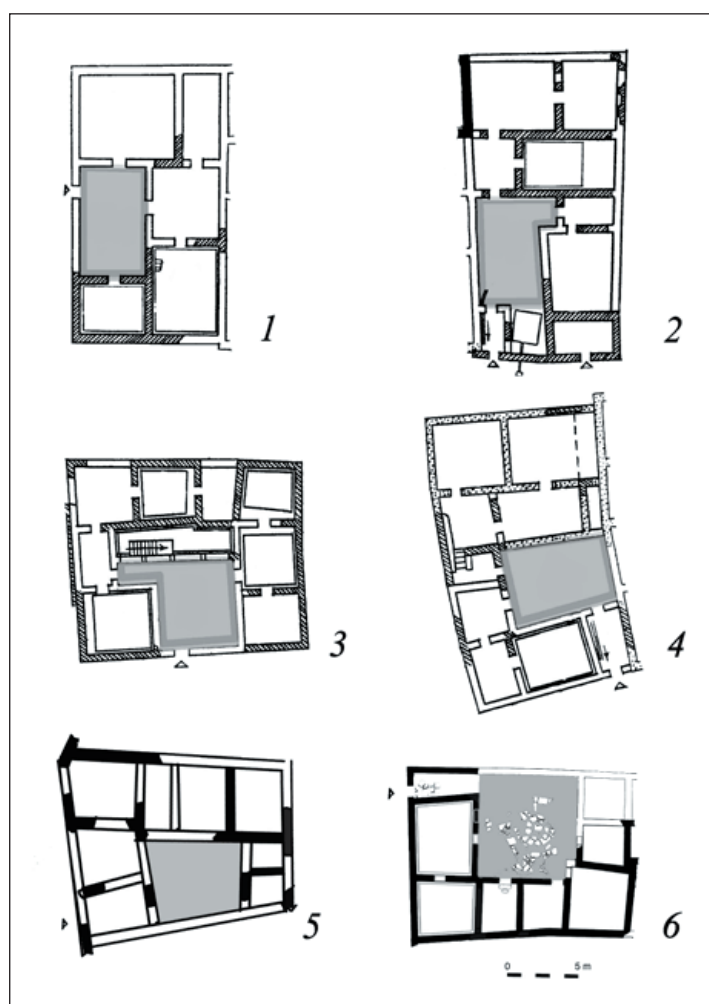
2 • Houses with Π-shaped arrangement of rooms: 1: House A-4; 2: House A-3; 3: House E-1; 4: House E-2; 5: House E-6; 6: Sector NGS, House II-3.

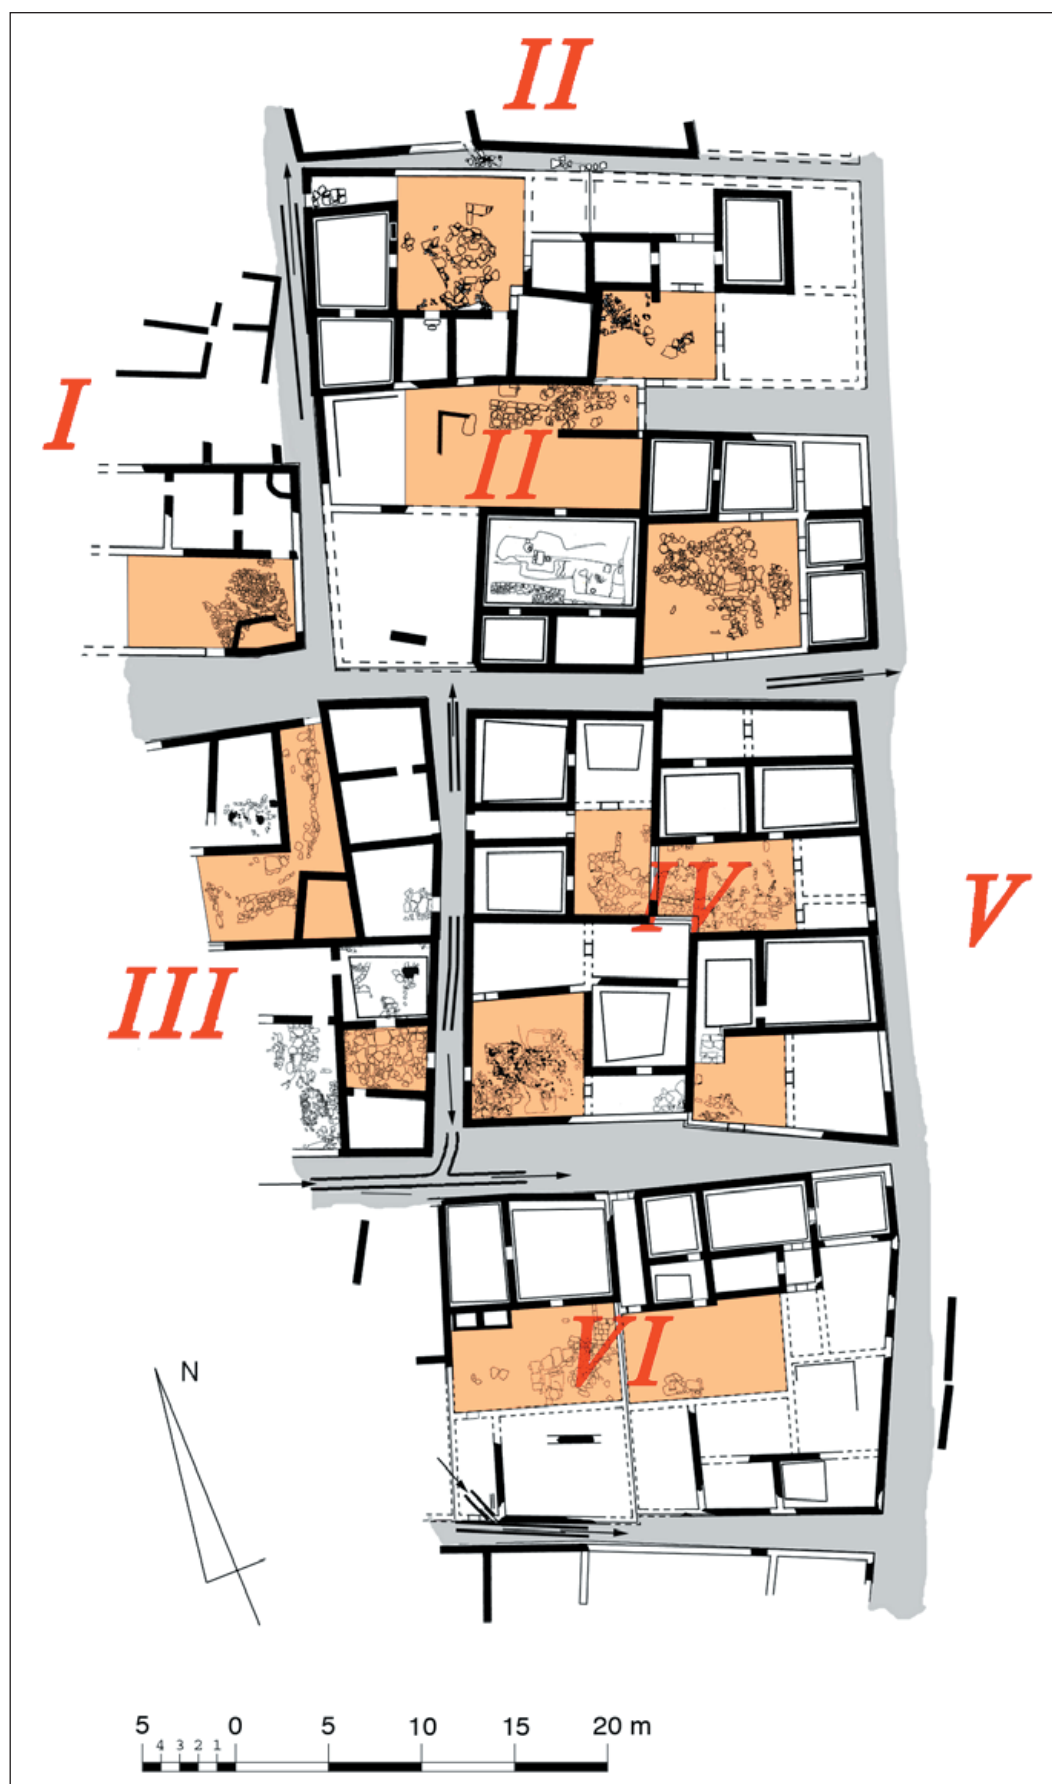
Houses of Sector NGS. Reconstruction of lay-out.
