1 • General view of the Lower City of Olbia.

Overview plan of Sector NGS.

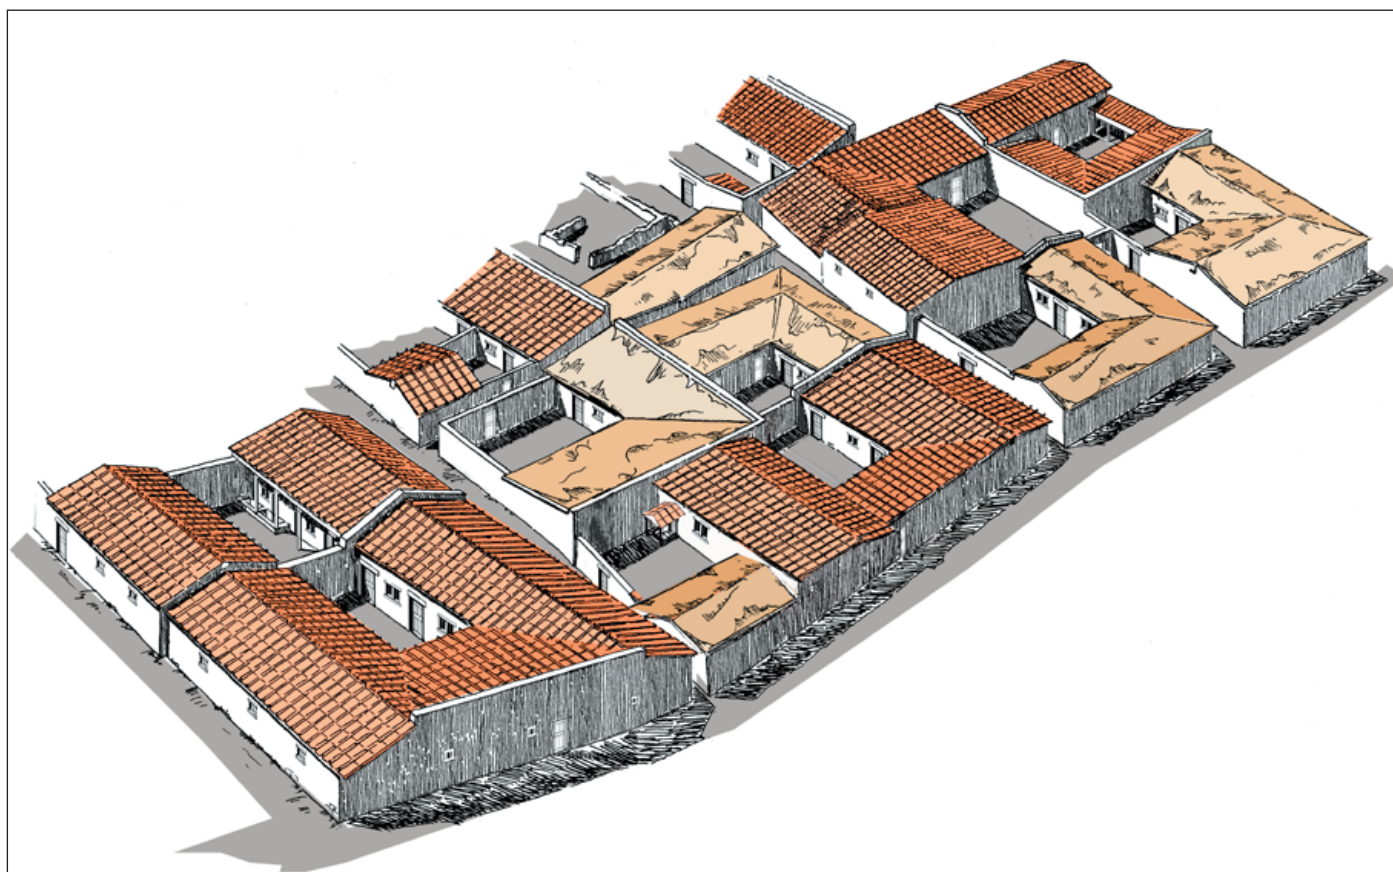
General view of the houseblocks in Sector NGS. Reconstruction. View from southeast.
